CASE STUDY

Diamapro® UV-HS Plus Microban Coating Effectively Resolves Safety Issue at a Cape Coral Hospital

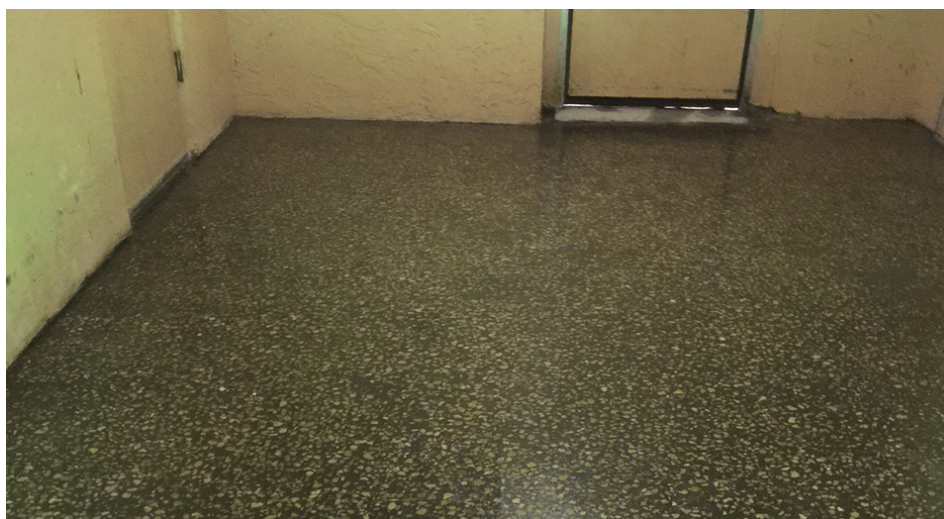
Concrete Floor Systems technicians met with hospital facilities personnel to provide an initial job site consultation that included both surface and substrate evaluation. It was determined

the morgue ramp had higher than average moisture content that was contributing to the degradation of the surface. The customer emphasized that minimal downtime was required during the repair and coating of the ramp. As the only means of egress from the morgue, the ramp was frequently used and an actual shutdown period wasn't possible. The morgue had to remain accessible as the work was performed. Concrete Floor Systems is familiar with the need for minimal down-time in hospitals. "We frequently encounter situations where shutdowns simply aren't feasible, particularly with health care facilities," We establish a working plan that accommodates this need, and have a proprietary ultraviolet cured product in Diamapro that eliminates any lost time due to curing. It's an ideal coating for these situations, and its benefits are extraordinary."

Concrete Floor Systems technicians recommended coating the floor with Diamapro UV-HS Plus once repairs had been made. Diamapro UV-HS Plus is a single component, aliphatic

urethane that is exceptionally resistant to water and chemicals and cures instantly upon exposure to ultraviolet light. Diamapro provides a highly durable, abrasion resistant finish. Photo initiators in the coating react with ultraviolet to form free radicals. These react with acrylate double bonds, cross-linking the molecules to form an exceptionally hard surface. To solve the problem of excess moisture, Concrete Floor Systems recommended applying Diamapro Moisture Control as a pre-treatment.

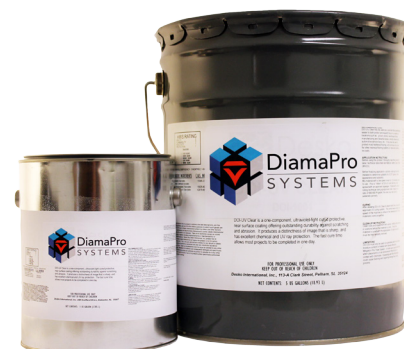
Diamapro Systems UV-HS Plus is one part, no mixing needed. It comes in 1 gallon or 5 gallon sizes and has an extremely long shelf life.

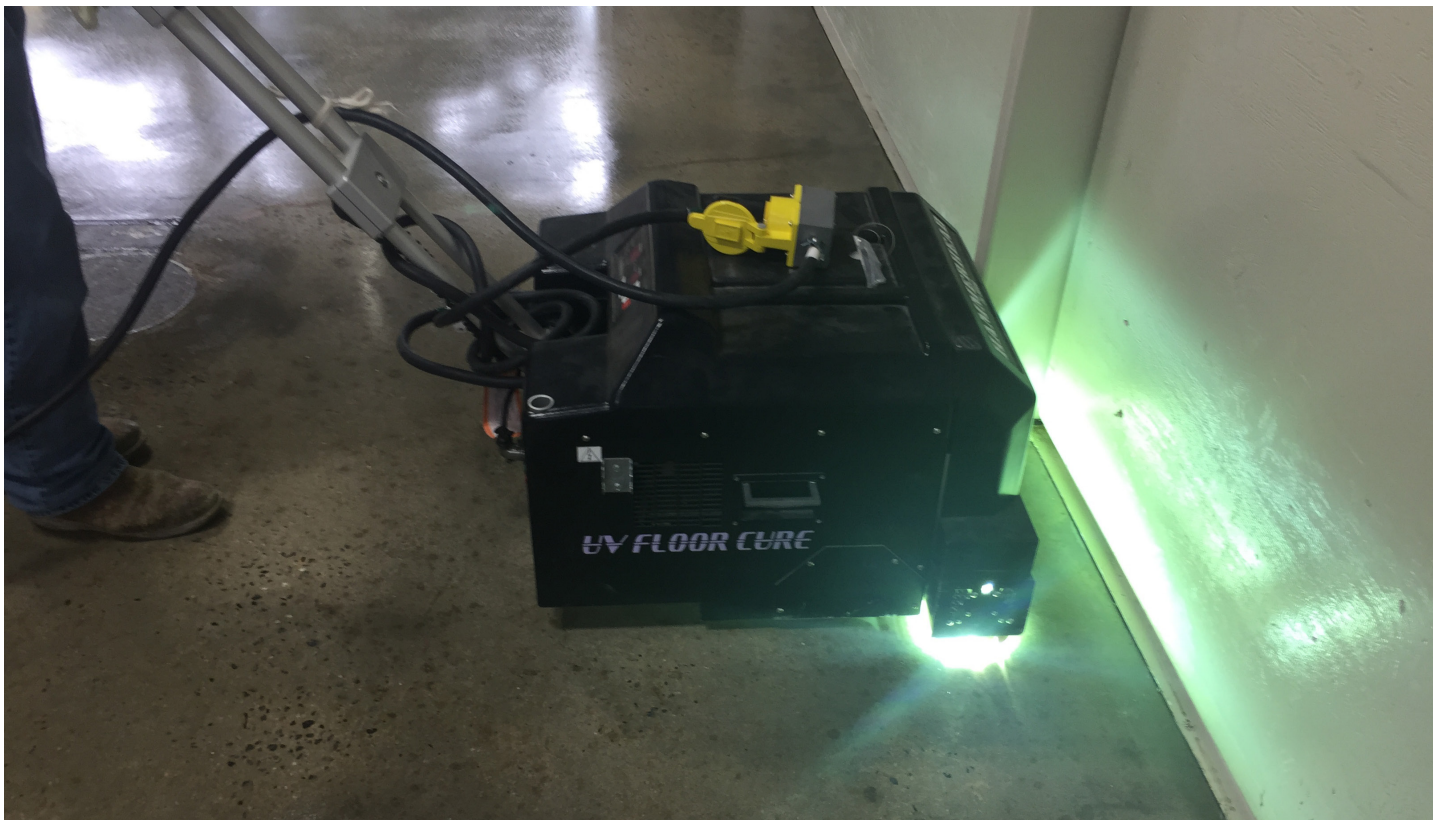
Appropriate repairs were made to the morgue ramp and pretreated the substrate with DiamaPro Moisture Control. When preparation was complete, DiamaPro UV-HS Plus matte was applied like a conventional urethane or epoxy. Squeegee out the product with a standard floor roller and lightly back rolling with a wider roller. Ideal coating thickness is approximately 1.6 mils. During the final coating 80-grit aluminum oxide was broadcast to increase slip resistance.

The DiamaPro coating was cured using an HID Bulldog 1700-A 110V, 1700 watt, automatically driven ultraviolet light. As the light passes over the coating curing occurs instantaneously and the floor can be returned to immediate service.
